DAM SAFETY SECTION CRITICAL INFRASTRUCTURE DIVISION

Downstream Hazard Assessment

DAM: Lake Deerwood Dam

INSPECTION DATE: May 22, 2012

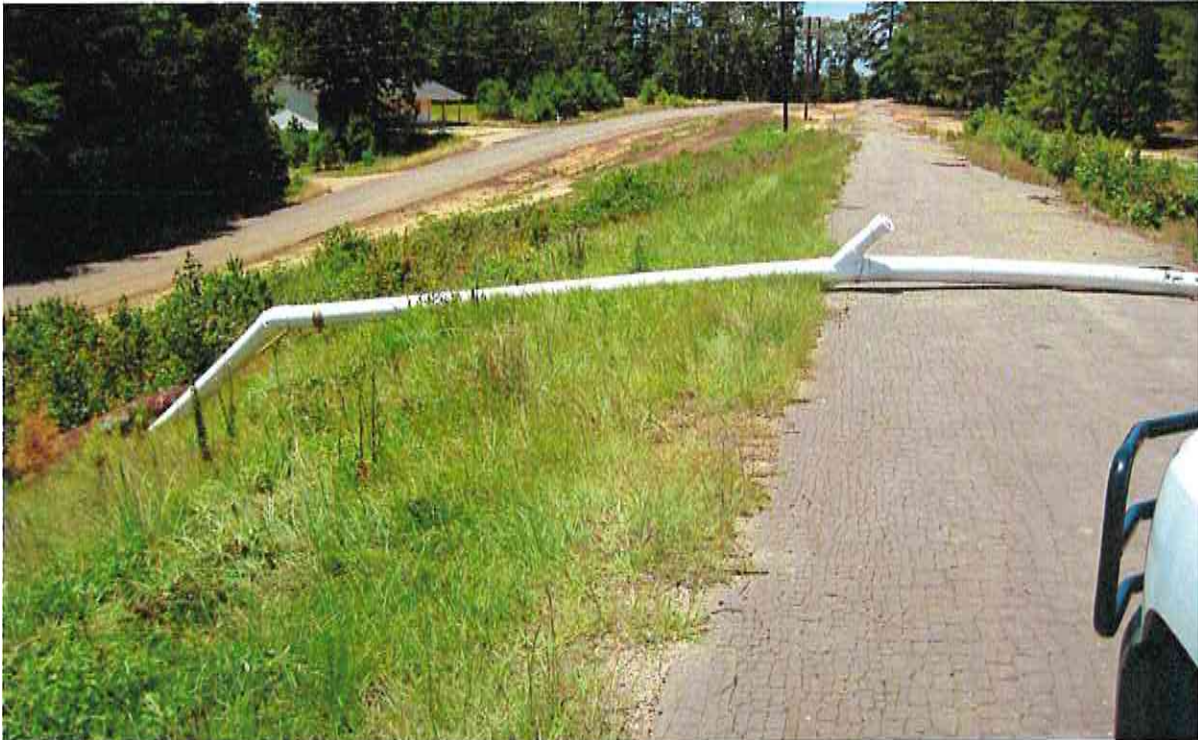
- An 8-inch PVC siphon was installed over the embankment to maintain the water level below the level of the damaged principal spillway inlet [Photos 1-3],

Photo 1: View of the 8-inch PVC siphon that was installed to lower the lake level.

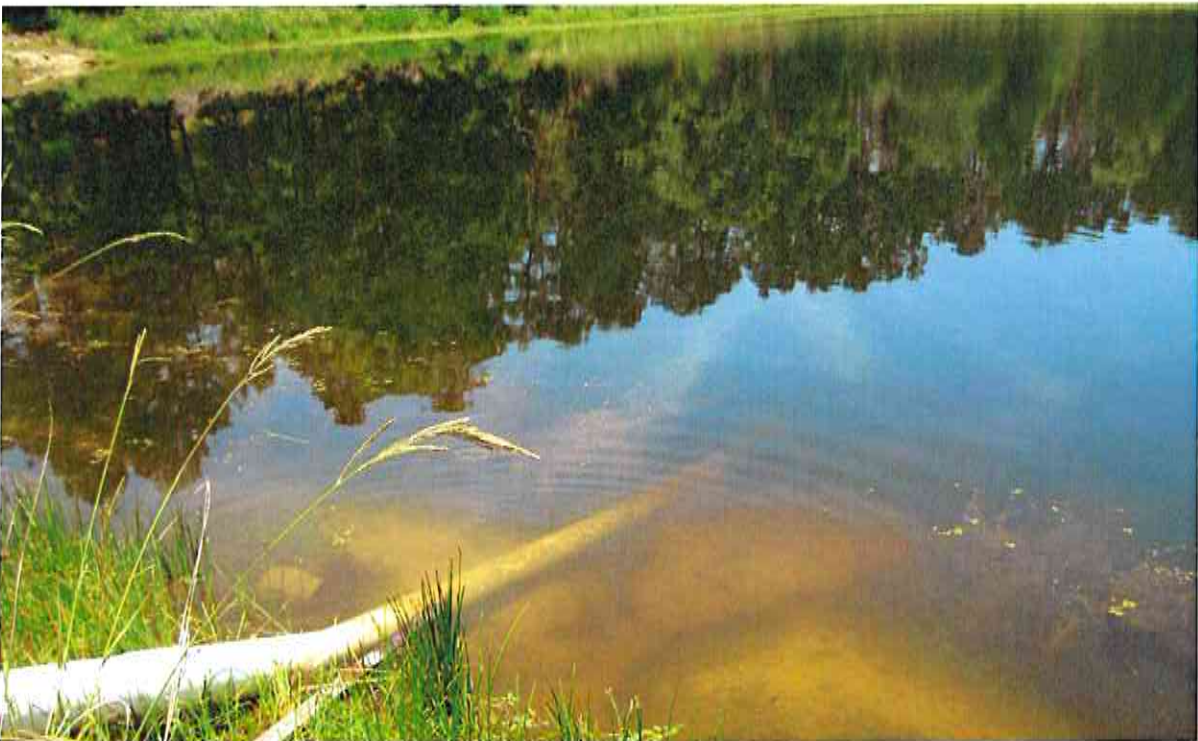
Photo 2: Upstream end of the siphon.

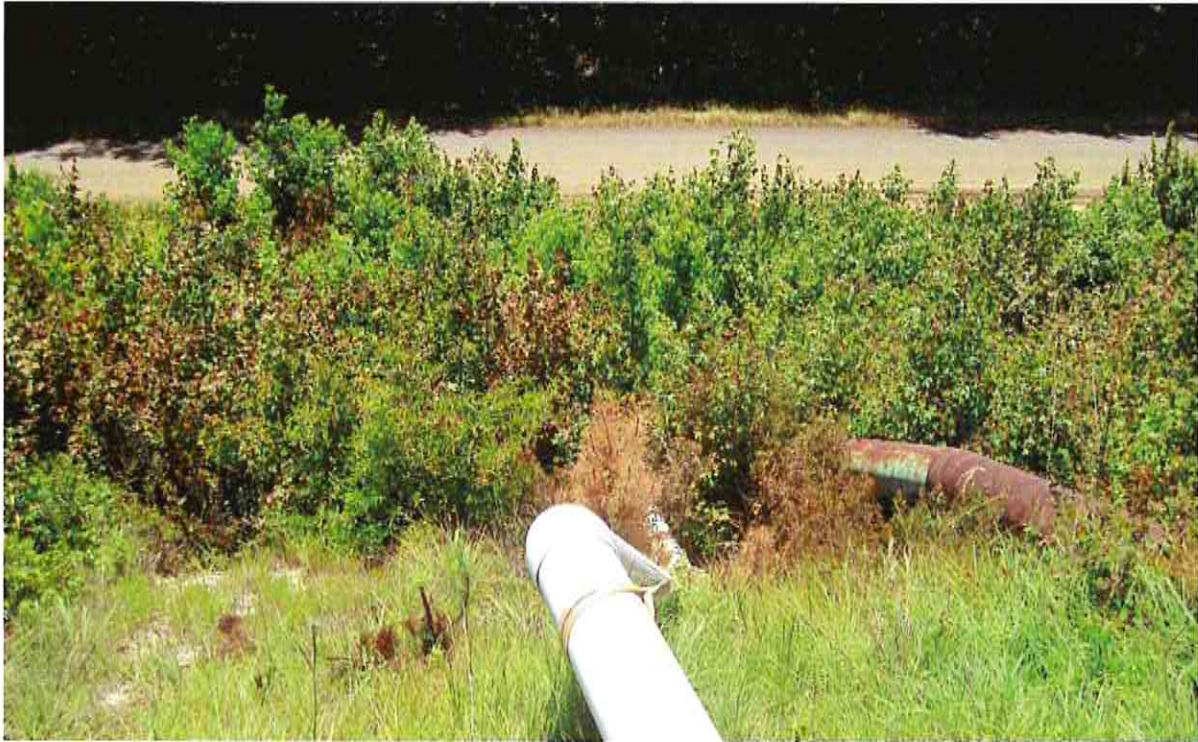
- The damaged principal spillway was still in place, but was not engaged,
- The siphon was not engaged during the inspection,
- The previously noted erosion of the downstream slope remains, but has not further deteriorated since the water level has been lowered,

Photo 3: Downstream end of the siphon. Note the existing deteriorated principal spillway pipe in the right of the photo.

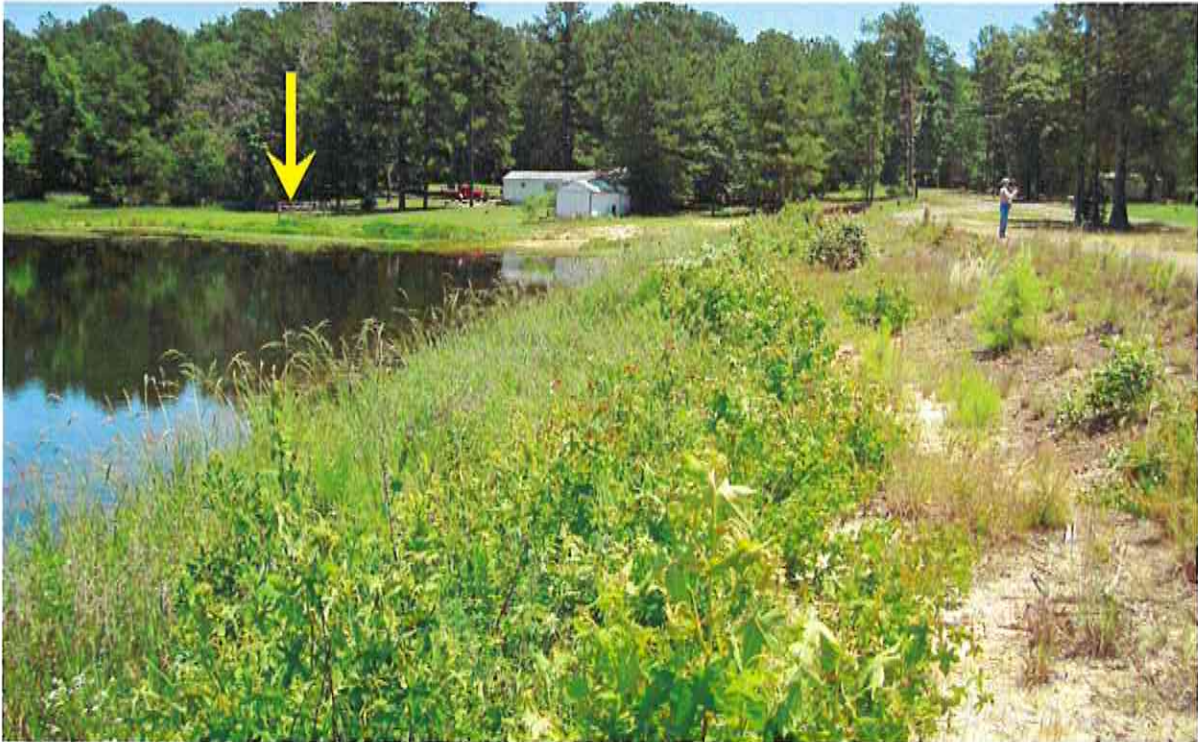
- The water level was measured with a hand level to be 3.6 feet below the crest of the principal spillway and 8.7 feet below the top of dam [Photo 4],
- Standing seepage was observed on the toe of the dam near the principal spillway [Photo 5],

Photo 4: View of the upstream slope and reservoir pool. Note the dock in the background is significantly higher than the water surface.

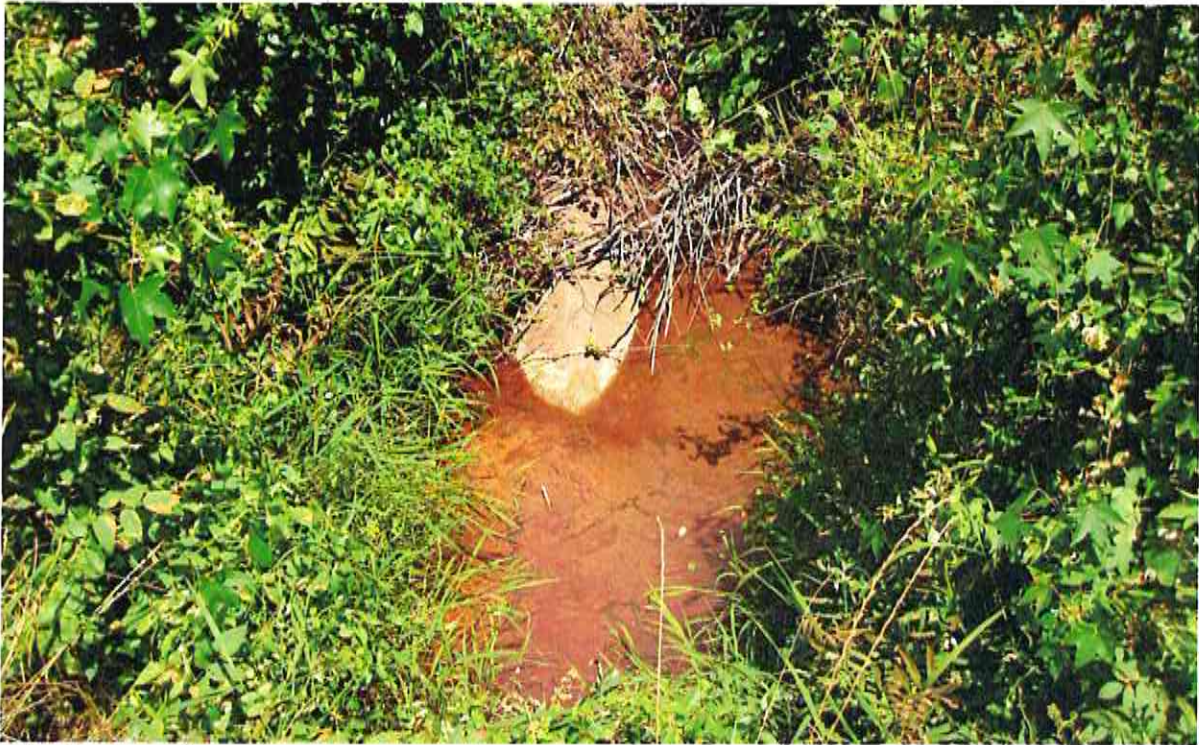
Photo 5: Standing seepage observed at the toe of the dam at the principal spillway pipe outlet.

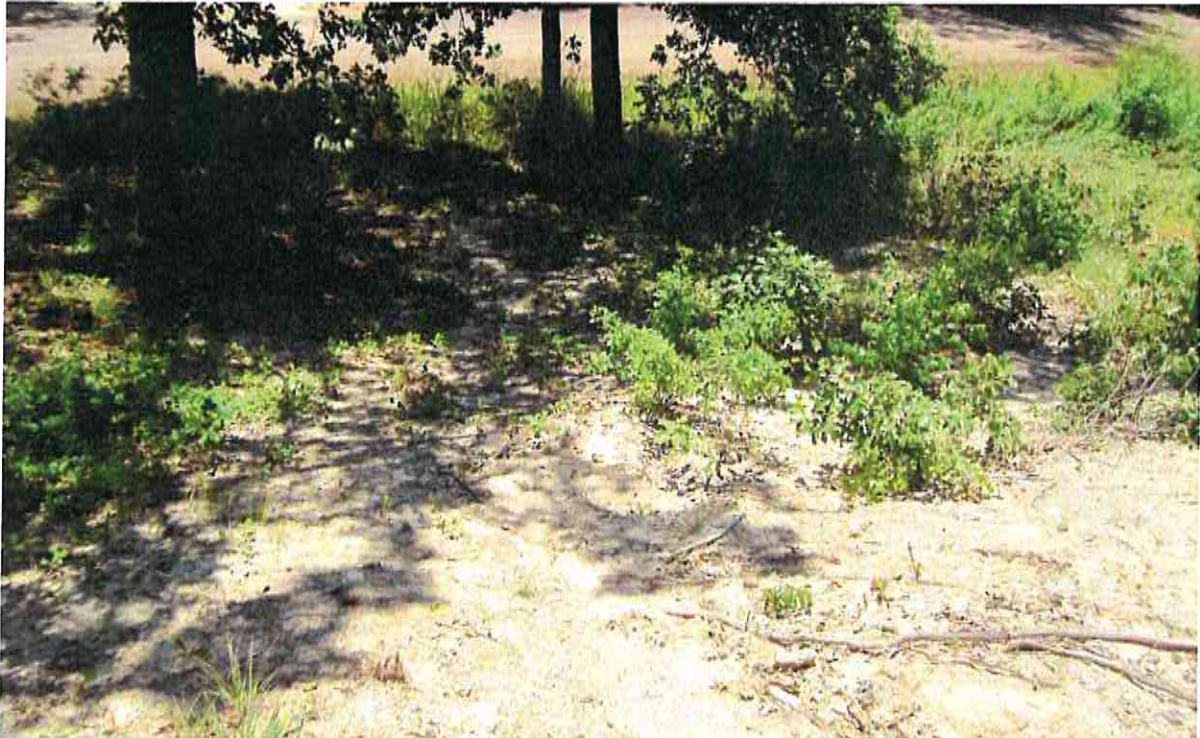
- The high phreatic surface on the downstream slope that was observed in the March 2010 inspection (when the principal spillway was engaged) was not observed during the current inspection [Photo 6],

Mr. Rivers relayed the Association's efforts to salvage and repair the dam given the limited funds available to the Association. He also stated that upon lowering of the water level, an abandoned beaver den was discovered on the upstream slope on the left end of the embankment, in the vicinity of where the high phreatic surface was observed during the March 2010 inspection. Mr. Rivers reported that the beaver den had been repaired by collapsing the burrow and compacting it with clay material.

Photo 6: Area of the downstream slope that was moist from seepage in the March 2010 inspection. The slope was dry during the current inspection. Mr. Rivers reported that a beaver burrow had been repaired on the upstream slope opposite this area.

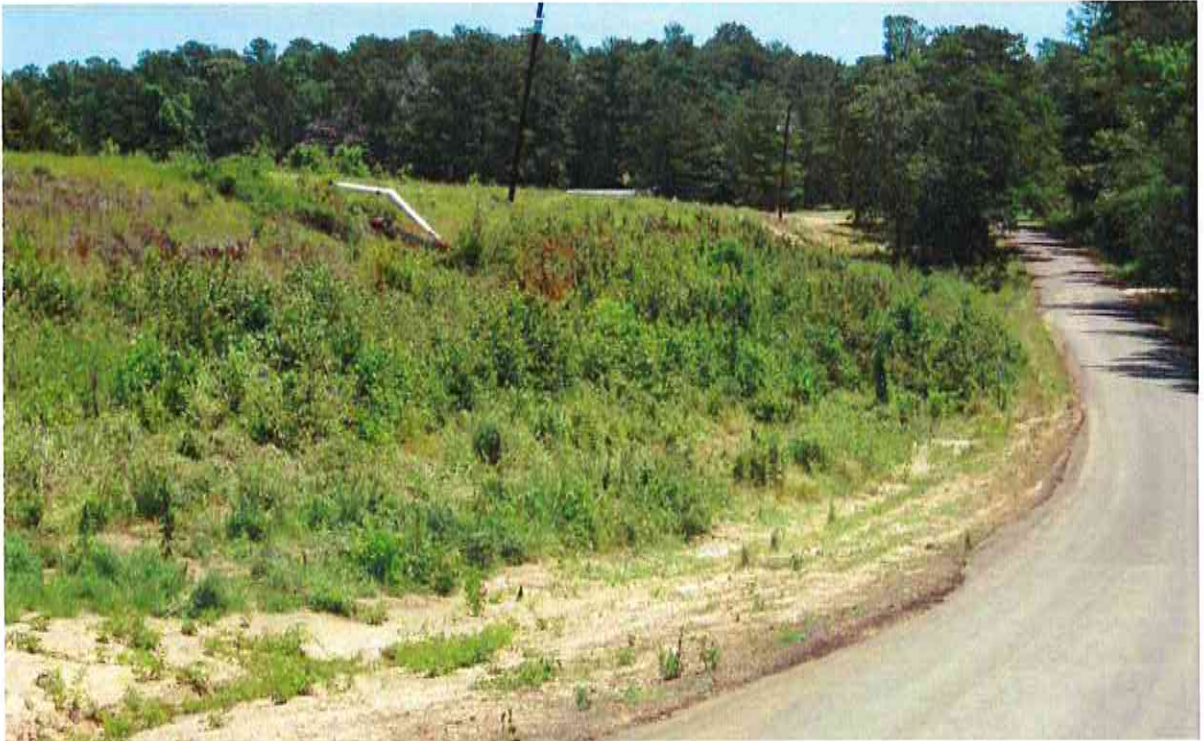
- Small trees were growing back from cut stumps [Photos 7-8], and
- Cut trees that were on the embankment in the March 2010 inspection had been removed.

Photo 7: Overall view of the downstream slope. Note the small trees re-growing from cut stumps. Also, note that the brush piled on the slope during the March 2010 inspection had been removed.

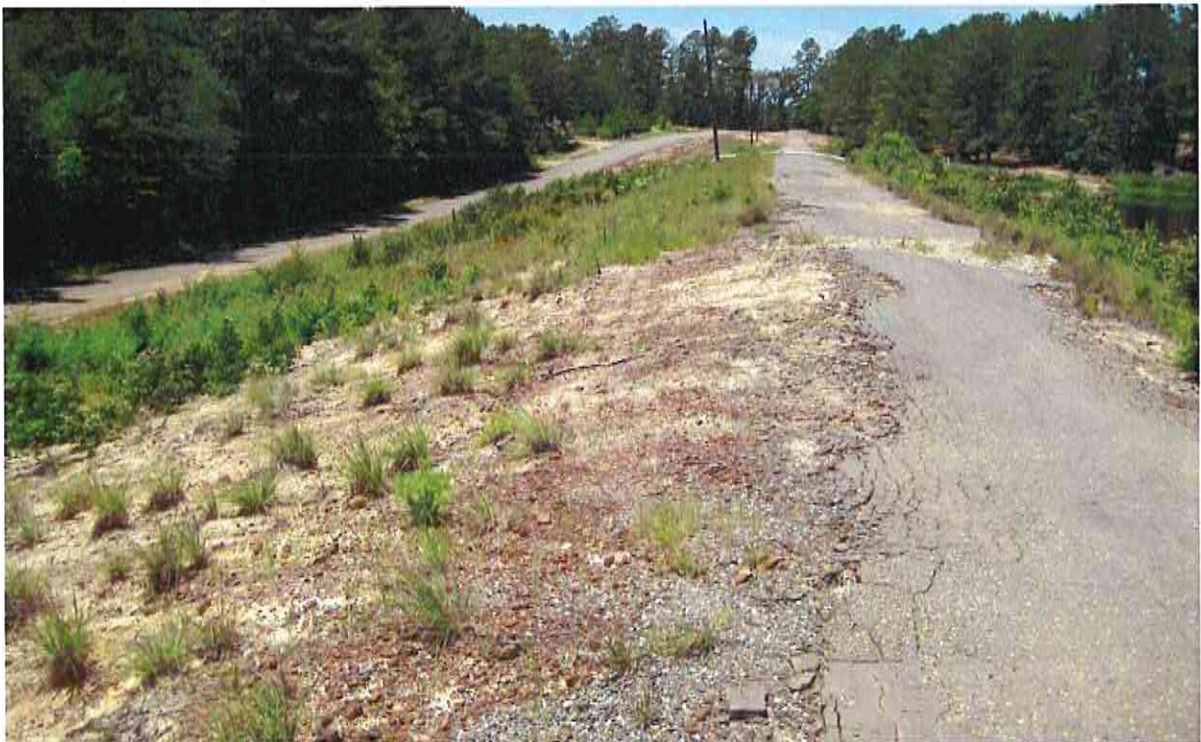
Photo 8: Another view of the dam from the left end of the crest.
